RESEARCH TECHNICAL REPORT Evaluation of Sprinkler Fire Protection of Retail Sales of Consumer Fireworks

Kristin L.T. Jamison

June 2019

FM Global 1151 Providence Hwy Norwood, MA 02062

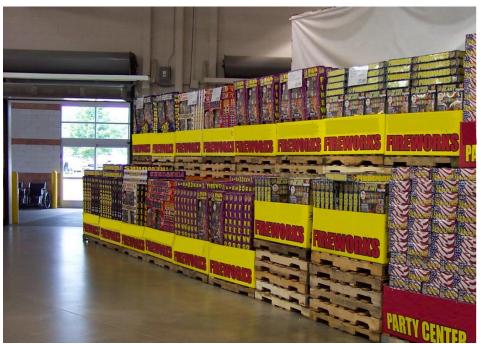
Figure 1-1: Example of fenced palletized arrangement.

Both palletized and gondola shelving were considered for this research. Gondola displays appear to be most prevalent at retail locations. Palletized displays typically contain packaged assortments and can be configured in a number of different ways. Figures 1-1 and 1-2 show two different types of palletized configurations, fenced and quad^{xiii}, respectively. An example of empty gondola shelving is pictured in Figure 1-3 [27] while an example of gondola shelving with high product density is given in Figure 1-4 [28].

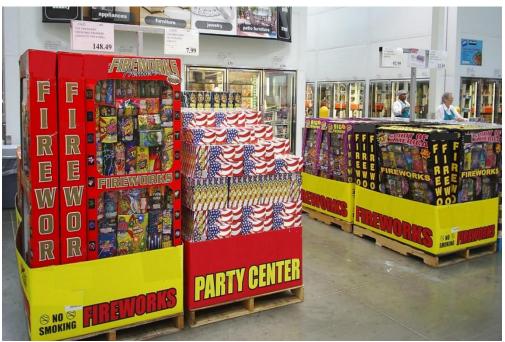
Figure 1-2: Example of quad palletized arrangement.

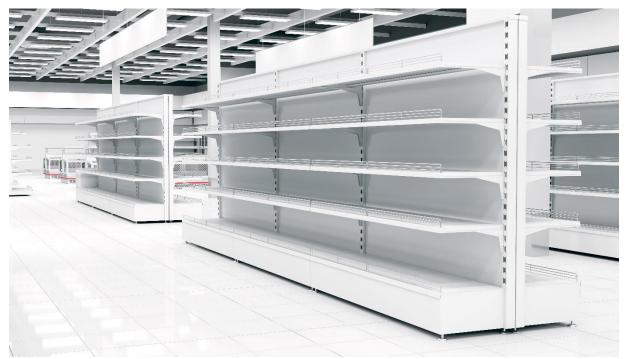
Figure 1-3: Example of empty gondola shelving [27].

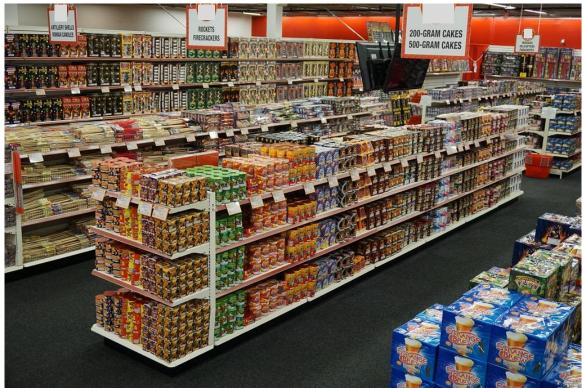
Figure 1-4: Example of gondola shelves with full product density [28].

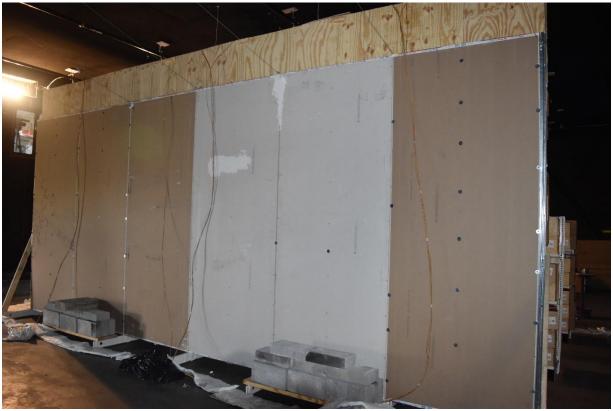
Figure 2-9: Sheet rock simulating interior wall on back of Side C.

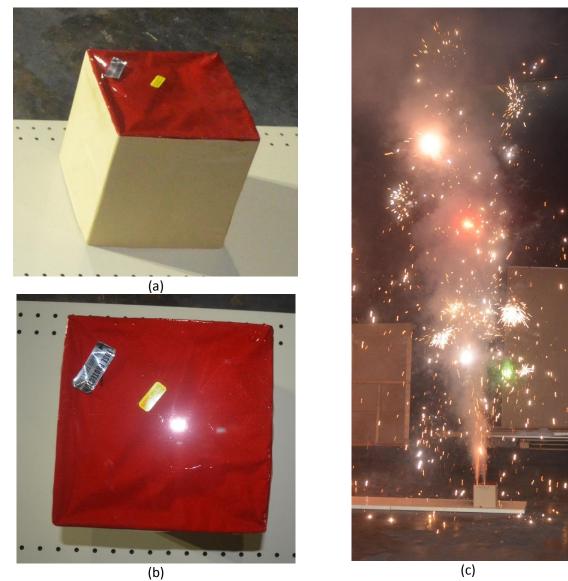
Figure 2-14: Single device (a) side and top, (b) cellophane top showing fuse, (c) example of one phase of discharge of device, display reaches approximately 4.9 m (16 ft) high.

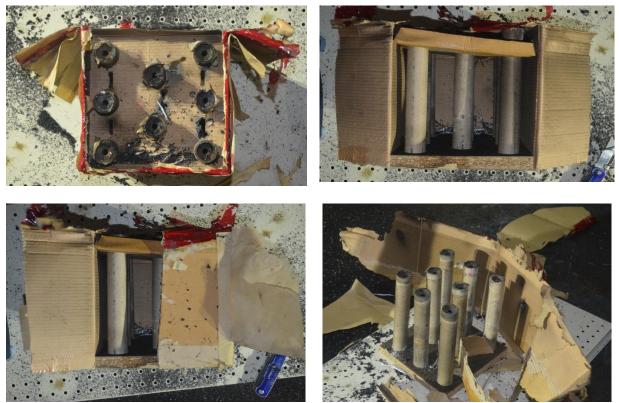
Figure 2-15: Discharged fireworks device that has been deconstructed showing engineered wood product base and cellulose tube and outer construction with red colored cellophane sheet on top.

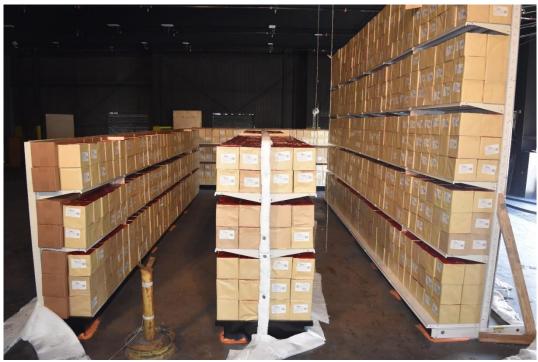
Figure 2-16: Final construction of test array looking eastward.

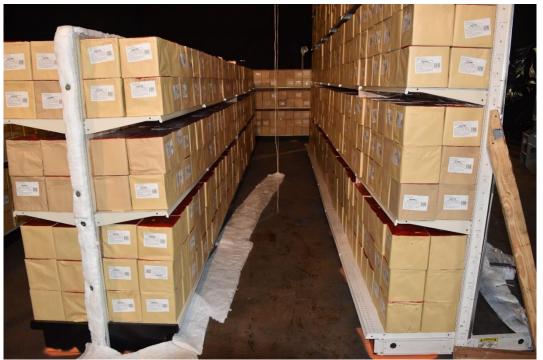
Figure 2-17: Final construction of test array looking eastward down ignition aisle (between Sides A and C).

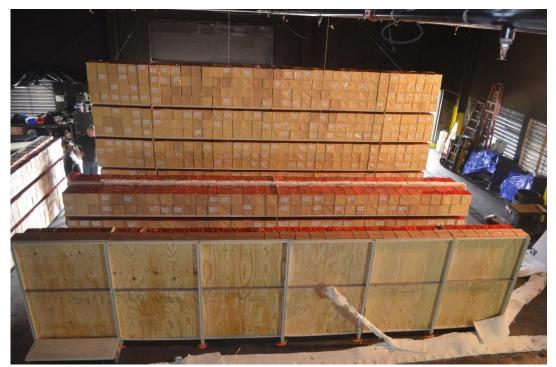
Figure 2-18: Final construction of test array looking southward.

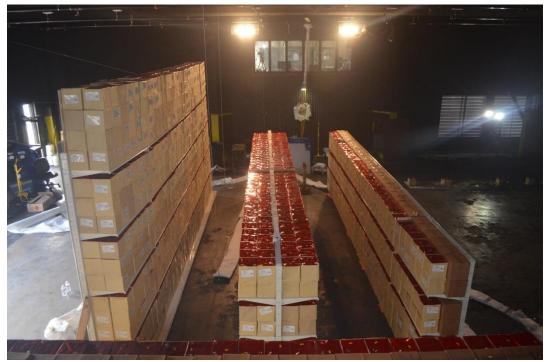
Figure 2-19: Final construction of test array looking westward.

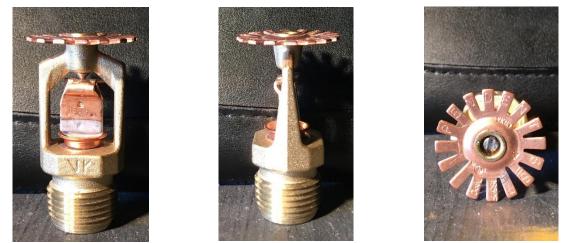
Figure 2-21: Ceiling-level sprinkler: K-factor 80 lpm/bar^{1/2} (5.6 gpm/psi^{1/2}), SR, Pendent, 74°C (165°F).

stated energy density for Side A. Test 1 was conducted using a design density of 8.1 mm/min (0.2 gpm/ft²); which is within the range of OH, Group 2 protection^{xviii}. The results of Test 1 were used to assist the design of Test 2 which assessed protection under a 9.1 m (30 ft) ceiling. Test 2 was conducted using a design density of 12.2 mm/min (0.3 gpm/ft²) maintained at the most remote branchline, which is within the range of EH, Group 1^{xix} protection. In both tests, pendent sprinklers with a nominal activation temperature of 74°C (165°F), standard response time index (RTI) and K-factor of 80 lpm/bar^{1/2} (5.6 gpm/psi^{1/2}) were installed on a 3.0 m x 3.0 m (10 ft x 10 ft) spacing with their thermal element located 0.3 m (12 in.) below the ceiling. Images of the sprinkler and piping system are provided in Figures 2-21 and 2-22, respectively.

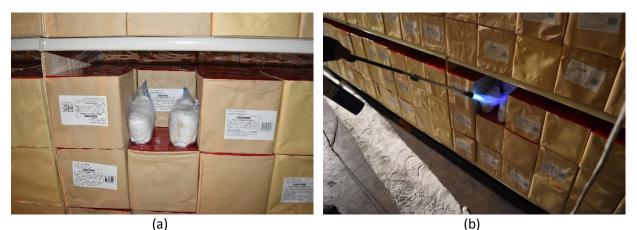
Figure 2-24: Ignition within the test array (a) close up showing ignitor placement, (b) ignition by application of propane torch.

Ignition was offset 0.3 m (1 ft) under one sprinkler and was achieved using two FM Global Standard Full Cellucotton Ignitors. Each was contained in a plastic bag and consisted of 113 g (4 oz.) of rolled cotton and 240 mL (8 oz.) of gasoline. The ignitors were placed in the bottom shelf of Side A, 0.3 m (1 ft) east of the transverse flame break where a single device had been removed to accommodate their placement. Images of the cotton material and final ignitor placement are shown in Figures 2-23 and 2-24(a). The ignitors were initiated by application of a propane torch as shown in Figure 2-24(b). An image of the ignitors shortly after being activated is given in Figure 2-25. The live firework device on which the ignitors sat was exposed to the ignition fire. The flames from the ignitors impinged on the shelf above promoting horizontal flame extension along the underside of the shelf which provided ignition potential for adjacent devices.

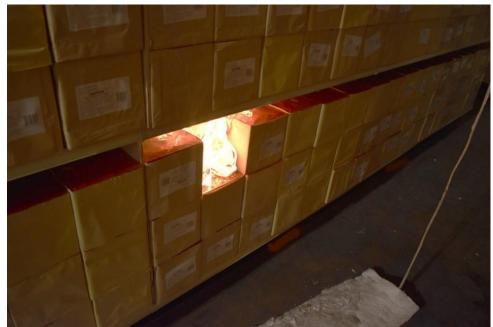
Figure 2-25: Initial flames shortly after ignition.

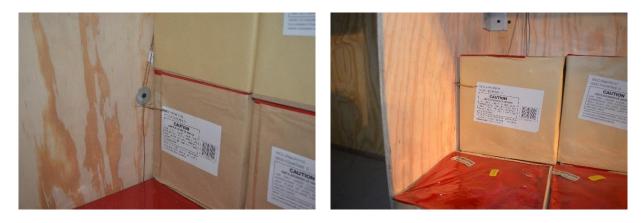
Figure 2-27: TC installation in shelving units (a) TC along perpendicular flame break, (b) TC located on transverse flame break. TCs located such that bead is 5.1 cm (2 in.) from the flame break.

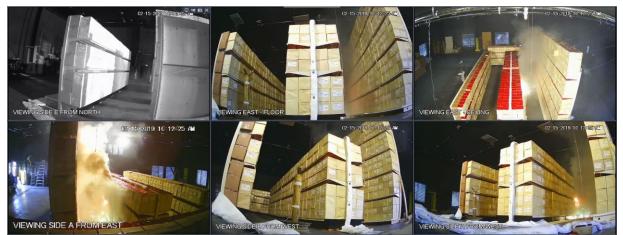
Figure A-2: Test 1 at 00:50: fire and smoke production intensifying in ignition region.

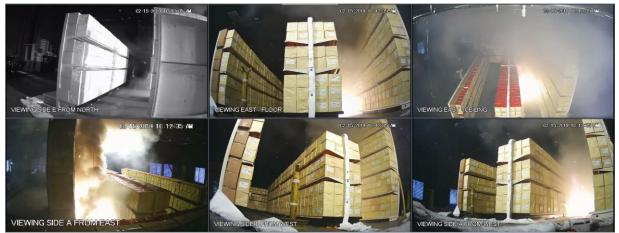
Figure A-3: Test 1 at 01:00: 3 s after 1st sprinkler activation, fire and smoke production intensifying in ignition region.

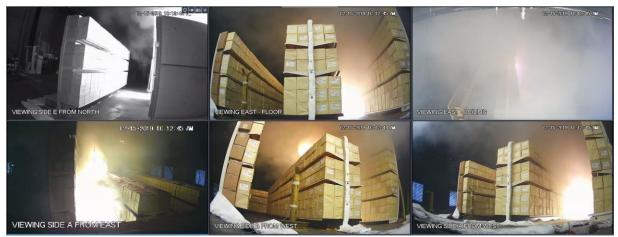
Figure A-4: Test 1 at 01:10: one sprinkler operating, fire and smoke production intensifying in Side A.

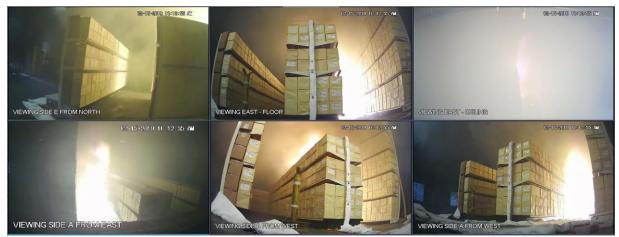
Figure A-5: Test 1 at 01:20: one sprinkler operating, fire and smoke production intensifying in Side A (camera 1 had transitioned from black and white colored infrared to full color due to the luminosity of the fire).

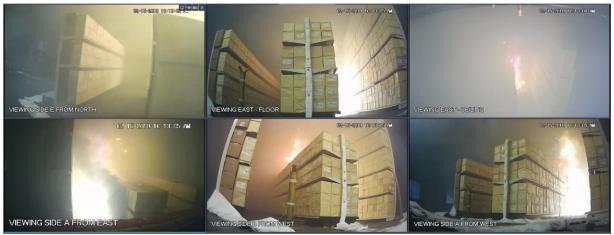
Figure A-6: Test 1 at 01:30: four sprinklers operating, fire and smoke production intensifying in Side A.

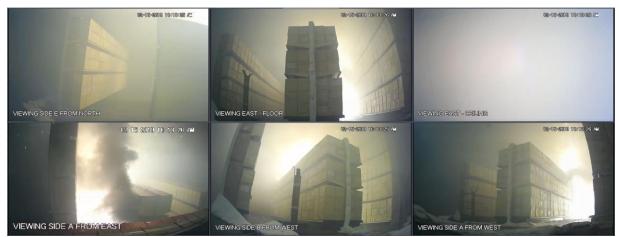
Figure A-8: Test 1 at 01:50: at least nine sprinklers operating, fire and smoke production intensifying.

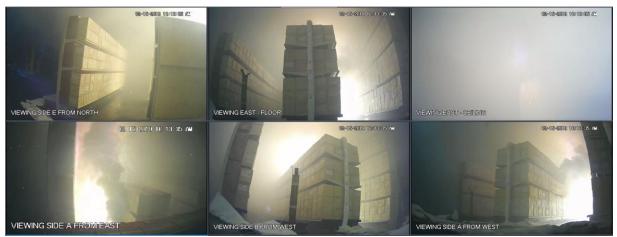
Figure A-9: Test 1 at 02:00: sprinklers continue to operate, fire and smoke production intensifying.

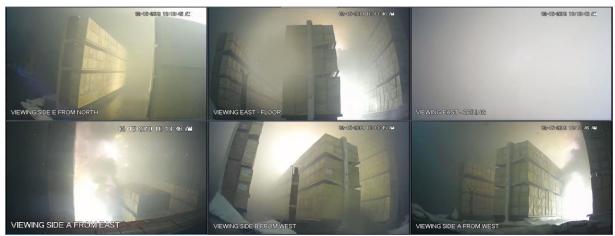
Figure A-10: Test 1 at 02:10: sprinklers continue to operate, fire and smoke production intensifying.

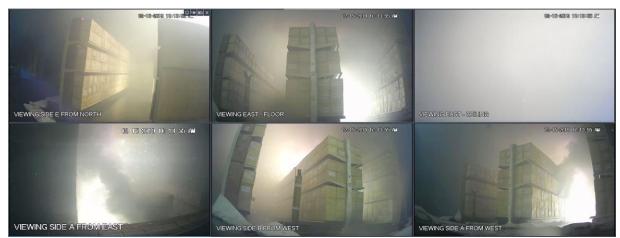
Figure A-11: Test 1 at 02:20: sprinklers continue to operate, ceiling-level gas temperatures (refer to Appendix B) are roughly steady state at maximum values.

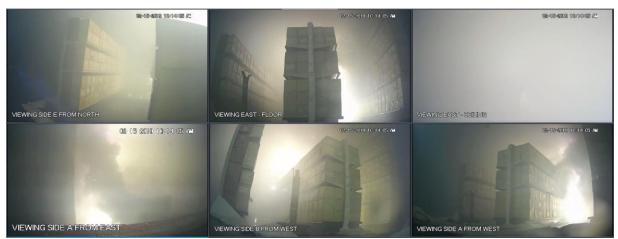
Figure A-12: Test 1 at 02:30: sprinklers continue to operate; the fire involves Side A and C.

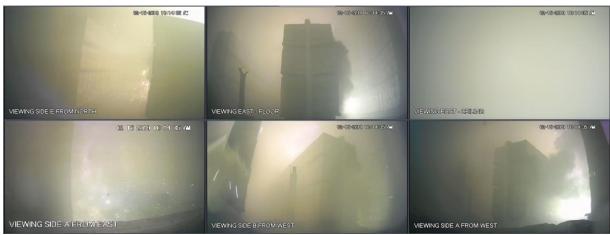
Figure A-13: Test 1 at 03:00: all 35 sprinklers have operated, sparks have been showering the lab since 00:33, visibility is decreasing.

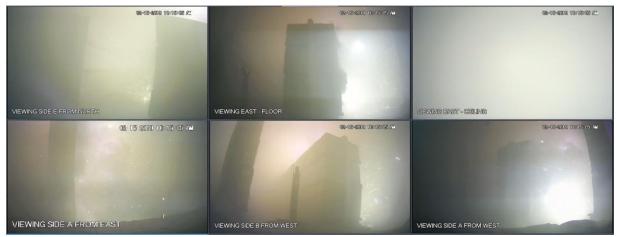
Figure A-14: Test 1 at 03:30: ceiling-level gas temperatures began a rapid decrease at approximately 03:10, visibility continues to decrease.

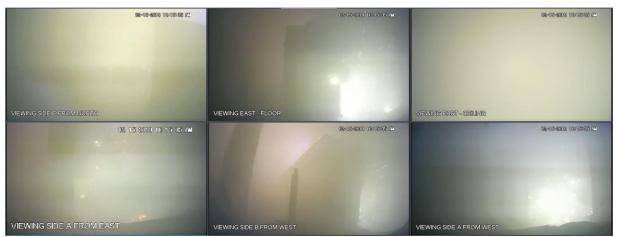
Figure A-15: Test 1 at 04:00: fire remains confined to Sides A and C, ceiling-level gas temperatures and visibility continues to decrease.

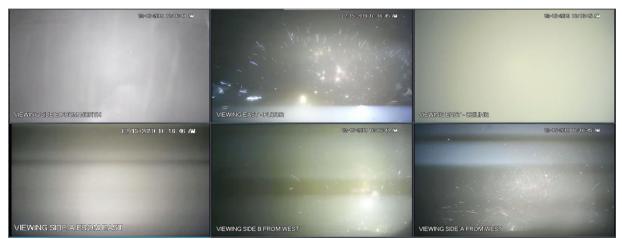
Figure A-16: Test 1 at 05:10: lab visibility completely obscured, camera 1 had transitioned to black and white colored infrared, cameras 2, 5 and 6 showing sparks visible in dark lab space.

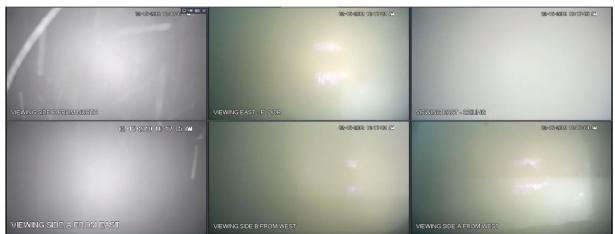
Figure A-17: Test 1 at 05:30: lab visibility completely obscured, cameras 1 and 4 are showing black and white colored infrared, cameras 2, 5 and 6 show flames at the west end of Side A in the bottom and middle shelves. Ceiling-level gas temperatures were all below 100°C (212°F) by 06:57. Continuous sparking was witnessed until approximately 10:00 with minor periodic sparking after that. The lab remained obscured until approximately 27:00.

Figure B-4: Test 1 temperatures in Side A: Shelf 1 (bottom) Temperature increase at 05:30 at location A1-1 coincides with visual observation (Figure A-17) of flames reaching west end of Shelf 1.

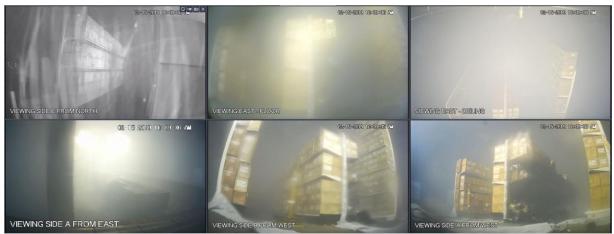
Figure A-18: Test 1 at 28:00: camera 1 in infrared shows water droplets, cameras 2, 5 and 6 show fire damage in bottom and middle shelf of Side A.

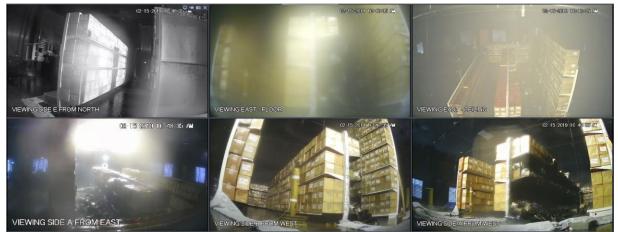
Figure A-19: Test 1 at 37:00: 2 minutes after test termination, damage confined to Sides A and C.

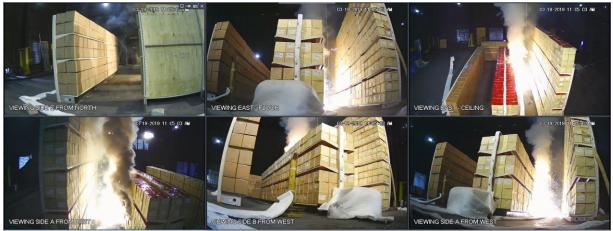
Figure A-20: Test 2 at 00:40: flames present on the face of Side A at ignition location.

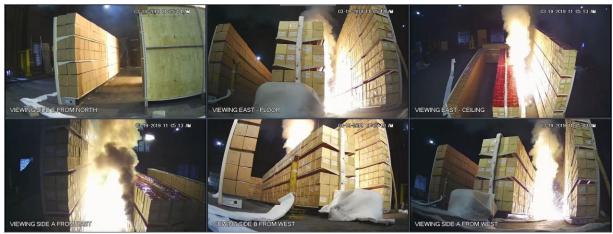
Figure A-21: Test 2 at 00:50: fire and smoke production intensifying in Side A with flames extending approximately 2.1 m (7 ft) above top of commodity.

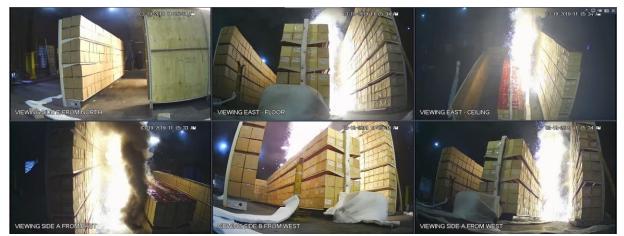
Figure A-22: Test 2 at 01:10: fire and smoke production intensifying in Side A.

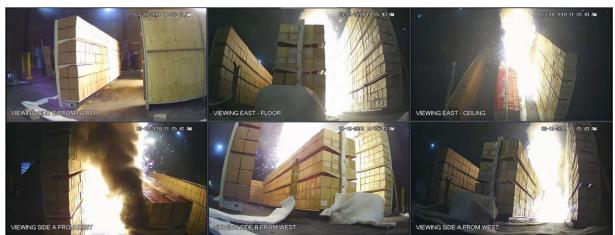
Figure A-23: Test 2 at 01:20: fire and smoke production intensifying in Side A, sparks being projected throughout lab space and showering down on top of Side B, Side C ignited at 01:19.

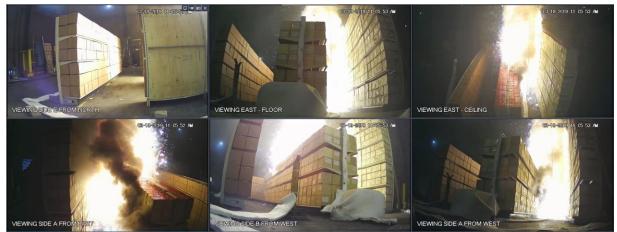
Figure A-24: Test 2 at 01:30: 2 s after 1st sprinkler activation, fire and smoke production intensifying, fireworks on top shelf of Side B became active at 01:23.

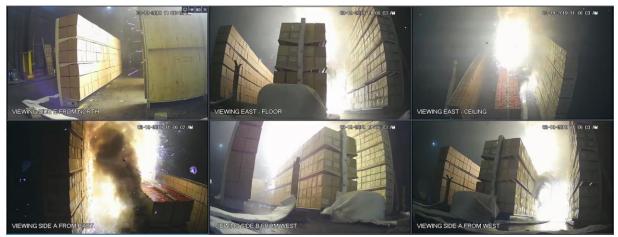
Figure A-25: Test 2 at 01:40: one sprinkler operating and fire and smoke production continue to intensify.

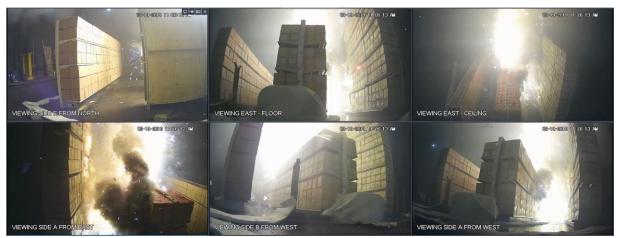
Figure A-26: Test 2 at 01:50: four sprinklers operating and fire and smoke production continue to intensify.

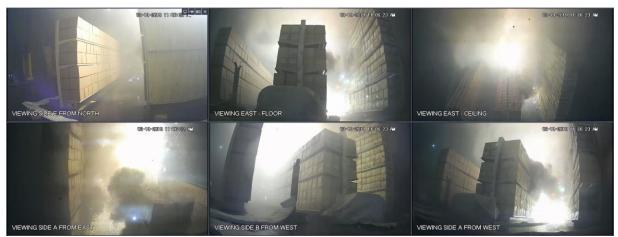
Figure A-27: Test 2 at 02:00: at least 10 sprinklers operating, fire continues to intensify and visibility is becoming obscured.

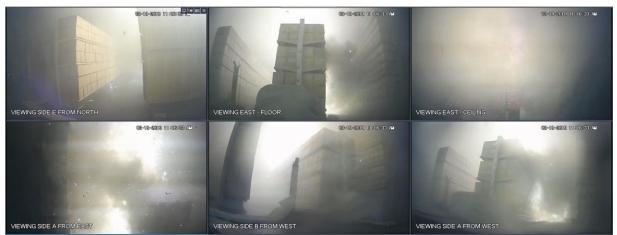
Figure A-28: Test 2 at 02:10: at least 20 sprinklers operating, fire continues to intensify and visibility is becoming more obscured.

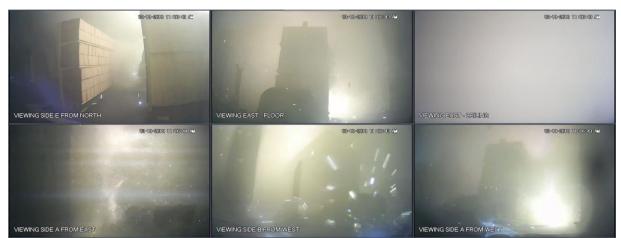
Figure A-29: Test 2 at 02:20: all 25 monitored sprinklers operating (all 36 sprinklers operated during the test, the operating time of the remaining 11 sprinklers was not recorded), ceiling-level gas temperatures (refer to Appendix B) are approaching their peak values, obscuration increases, camera 5 showing example of projectile sparks.

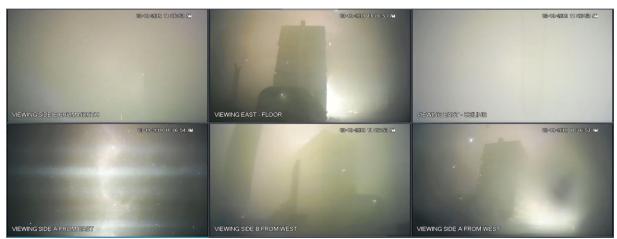
Figure A-30: Test 2 at 02:30: fire confined to Sides A and C, visibility decreasing.

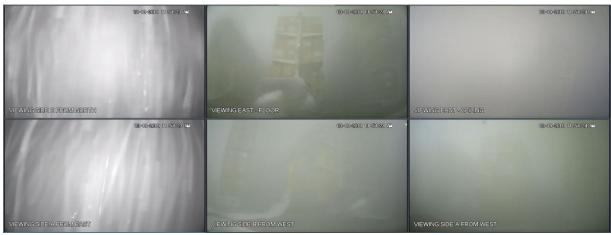
Figure A-33: Test 2 at 50:00: lab obscuration began to decrease at approximately 45:00, cameras 1 and 4 are in black and white colored infrared mode showing water droplets.

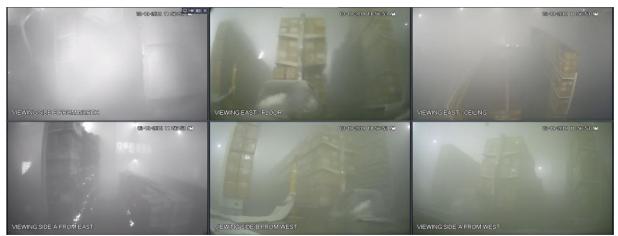
Figure A-34: Test 2 at 52:30: 30 s after test termination, visibility returning, camera 4 infrared showing heat (white in color) in Sides A and C.

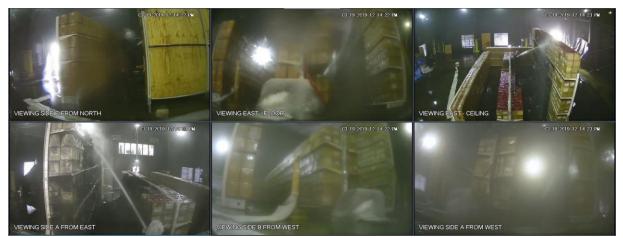
Figure A-35: Test 2 at 70:00: 18 minutes after test termination, camera 3 and 4 showing application of firefighter hose stream and damage to Sides A, B and C.

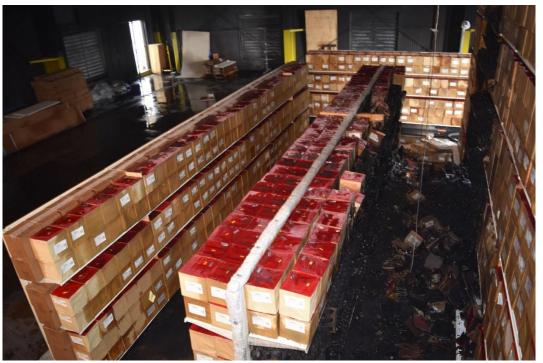
Figure C-3: Test 1 overview of damage looking toward east. Commodity shown collapsed into the aisle between Sides A and C.

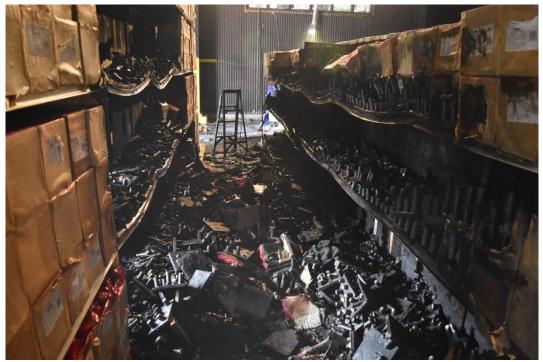
Figure C-4: Test 1 damage to Sides A (right) and C (left), looking toward west, with collapsed commodity in aisle which occurred during the test and not as a result of firefighting efforts.

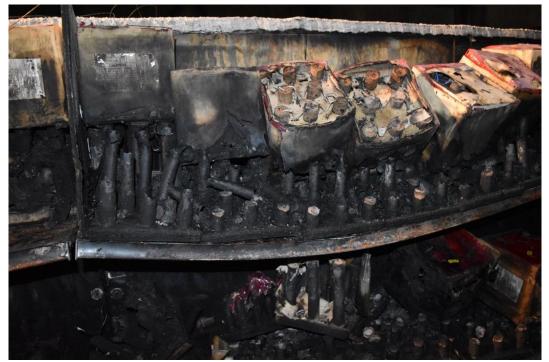
Figure C-6: Test 1 damage to top shelf commodity in Side A vertically aligned with ignition location (which was in bottom shelf).

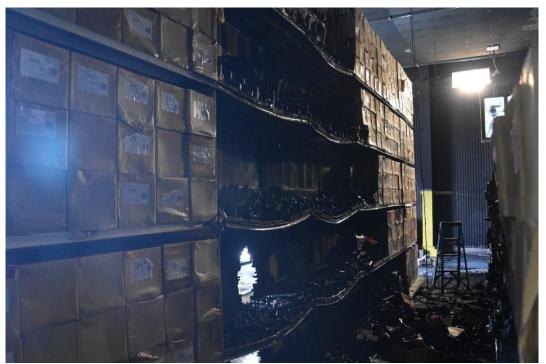
Figure C-7: Test 1 damage to Side C looking toward west. Transverse flame break located on left of image where commodity remains intact. Center of image shows burn through of longitudinal flame break (sheet rock backing remained intact at test conclusion and was removed post-test).

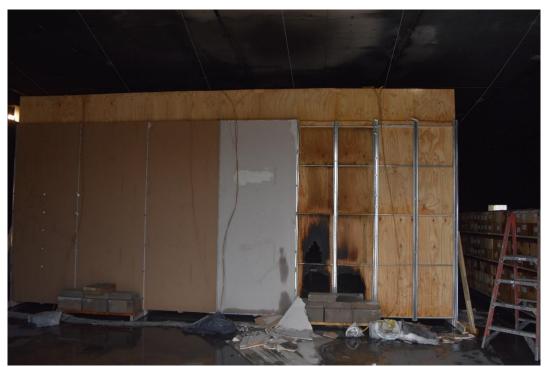
Figure C-8: Test 1 damage to Side C. Showing back of Side C where sheet rock has been removed post-test to inspect the burn through of the longitudinal flame break.

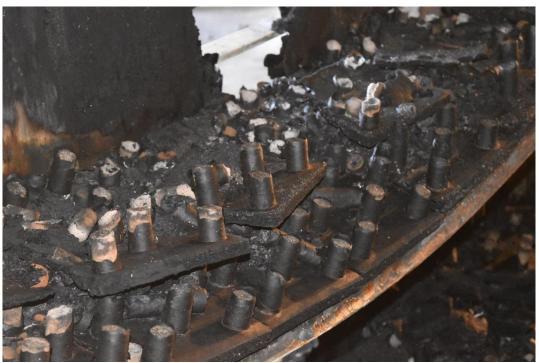
Figure C-9: Test 1 detail of typical residual commodity in highly effected regions. Specific location in Side C, second shelf.

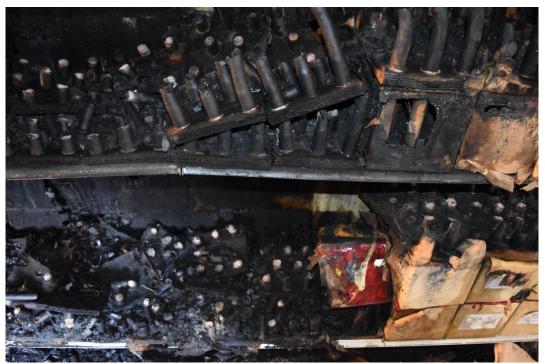
Figure C-10: Test 1 detail of typical residual commodity in regions where flame spread ceased.

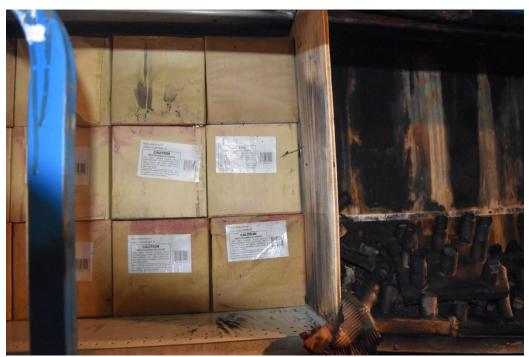
Figure C-11: Test 1 showing example of unburned commodity on one side of flame break and burned commodity on the other. Location in Side C. Note some commodity has been removed as part of the post-test deconstruction process.

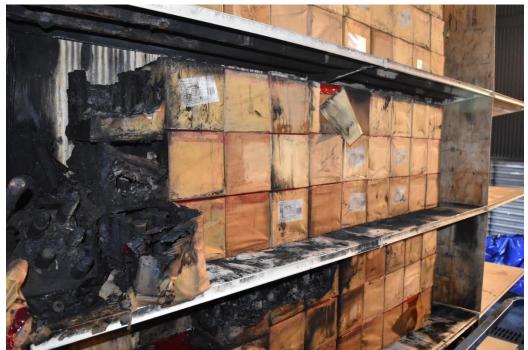
Figure C-12: Test 1, west side of Shelves 3, 4 and 5 in Side C showing examples of locations where flame spread ceased in the absence of a flame break. Shelf 3 provides an example of the flame spread that occurs when the flames are channeled along the underside of the shelves.

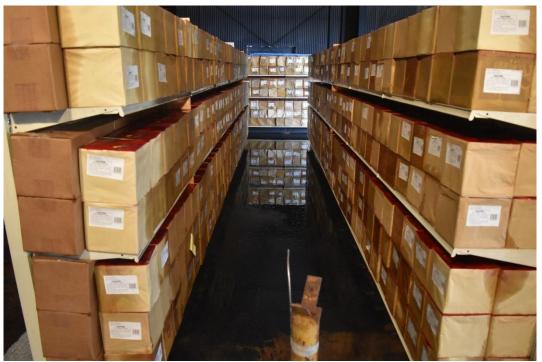
Figure C-13: Test 1 post-test image of Side B (right) and Side D (left) with Side E at the end of the aisle. These three shelving units sustained water damage only (no fire).

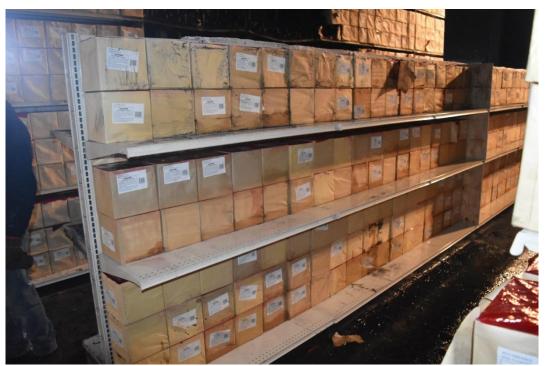
Figure C-14: Test 1 Side B. Front row of commodity has been removed during the post-test deconstruction process to inspect for potential fire damage. Side B sustained no fire damage to the commodity.

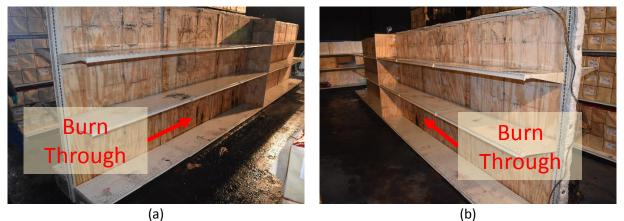
Figure D-15: Test 1 Side B after commodity has been removed showing localized areas of burn through of the longitudinal flame break from fire located in Side A (a) looking westward (b) looking eastward. Detail image shown in Figure C-16.

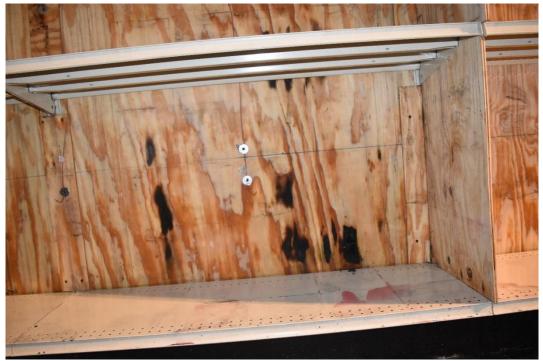
Figure C-16: Test 1 Side B after commodity has been removed showing localized area of burn through of longitudinal flame break in bottom shelf directly behind ignition location.

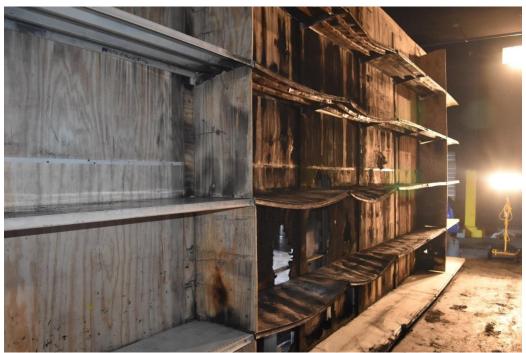
Figure C-17: Test 1 Side C (looking westward) after commodity has been removed showing transverse flame breaks intact, localized burn through of longitudinal flame break, and deformation of metal shelves.

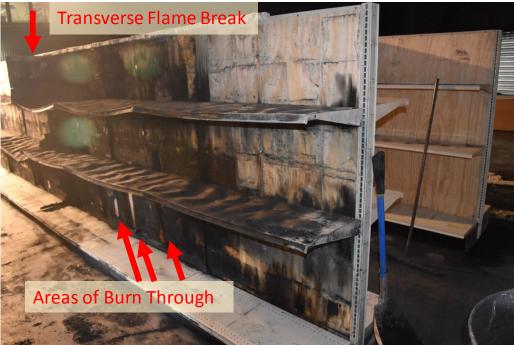
Figure C-18: Test 1 Side A (looking westward) after commodity has been removed showing transverse flame breaks on bottom and middle shelves consumed but intact on top shelf, examples of burn through of longitudinal flame break, and deformation of metal shelves.

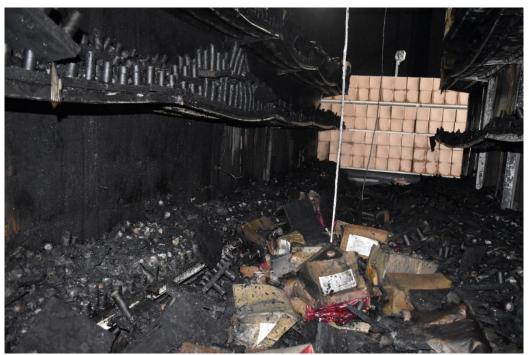
Figure C-21: Test 2 damage to Sides A (right) and C (left), looking toward east, with collapsed commodity in aisle which occurred during the test and not as a result of the firefighting efforts.

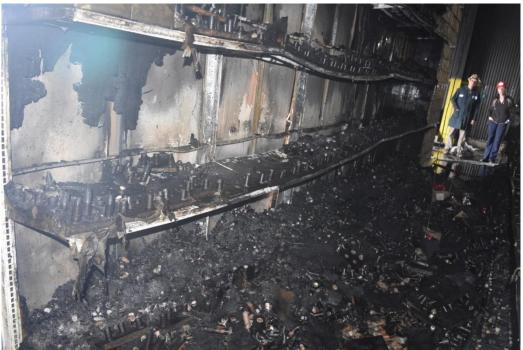
Figure C-22: Test 2 Side C looking toward west, shelves 1-3, showing sheet rock that backs longitudinal flame break which is nearly completely consumed in this region, transverse flame breaks consumed on west, intact on east, fire damage at eastern end in shelves 1-4.

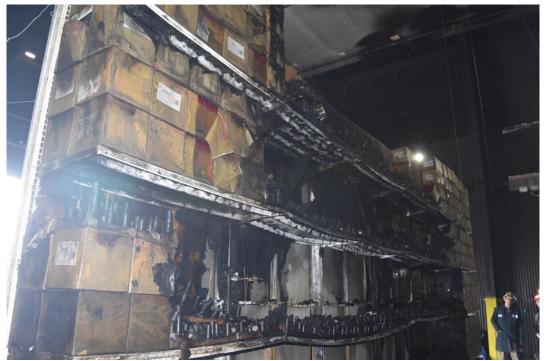
Figure C-23: Test 2 Side C looking toward west, shelves 3-5, transverse flame break on shelves 4 and 5 (top) intact.

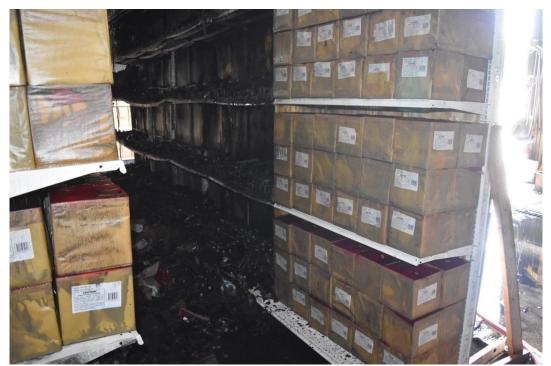
Figure C-24: Test 2 Side C looking toward east, shelves 1-3, fire damage reached transverse flame break on shelves 1-3 but did not burn through them.

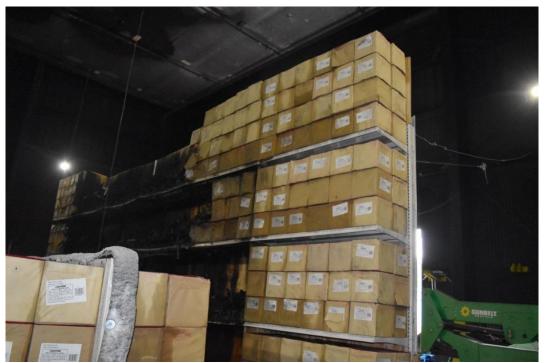
Figure C-25: Test 2 Side C, east side on left, west on right, shelves 3-5, fire damage reached transverse flame break on west side of shelf 3 but did not burn through and flame front ceased on west side of shelves 4 and 5 prior to reaching transverse flame breaks.

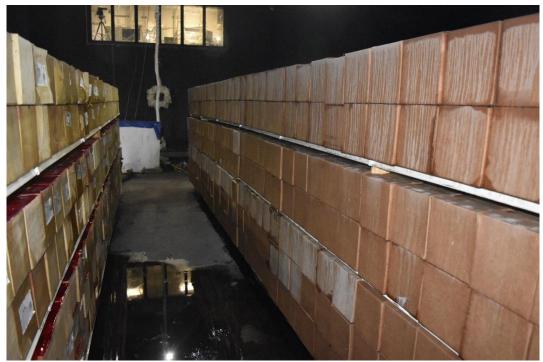
Figure C-26: Test 2 post-test image of Side B (left) and Side D (right) looking westward. Side D sustained water damage only (no fire). Fireworks on the top shelf of Side B sustained fire damage.

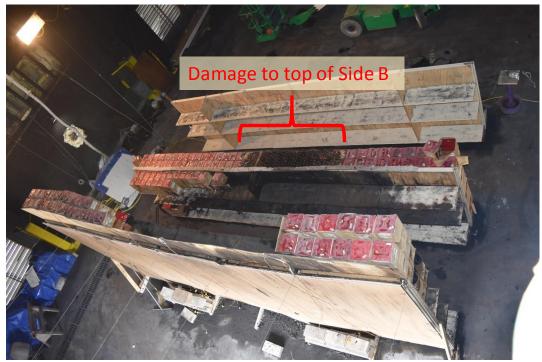
Figure C-27: Test 2 shown from aerial perspective with commodity partially removed and highlighting location on Side B where fire damage was sustained.

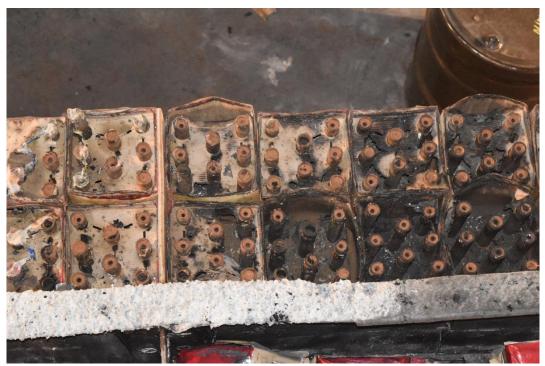
Figure C-28: Test 2 Side B detail of fire damage, a total of 22 fireworks devices became active in this location.

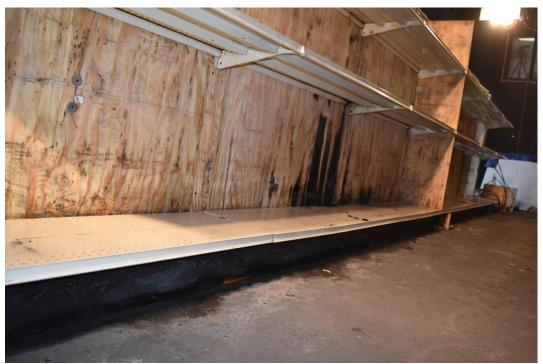
Figure C-29: Test 2 Side B after commodity has been removed showing localized area of burn through of longitudinal flame break in bottom shelf behind ignition region. See Figure C-30 for a close up image of this burn through.

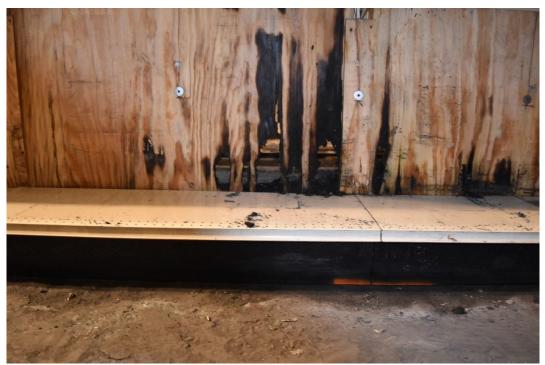
Figure C-30: Test 2 Side B after commodity has been removed showing localized area of burn through of longitudinal flame break in bottom shelf behind ignition region.

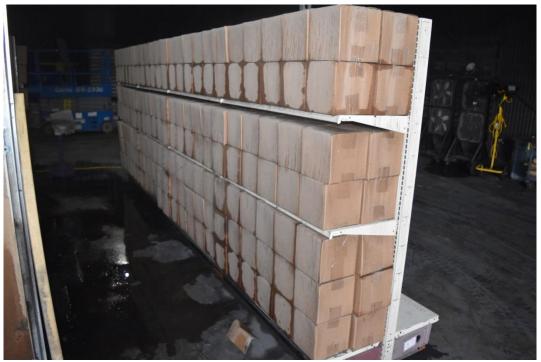
Figure C-31: Test 2 post-test image of Side E which sustained water damage only (no fire).
