RESEARCH TECHNICAL REPORT
*Flammability Characterization
of Lithium-ion Batteries in
Bulk Storage*

Benjamin Ditch and Jaap de Vries

March 2013

FM Global
1151 Boston-Providence Turnpike
Norwood, MA 02062

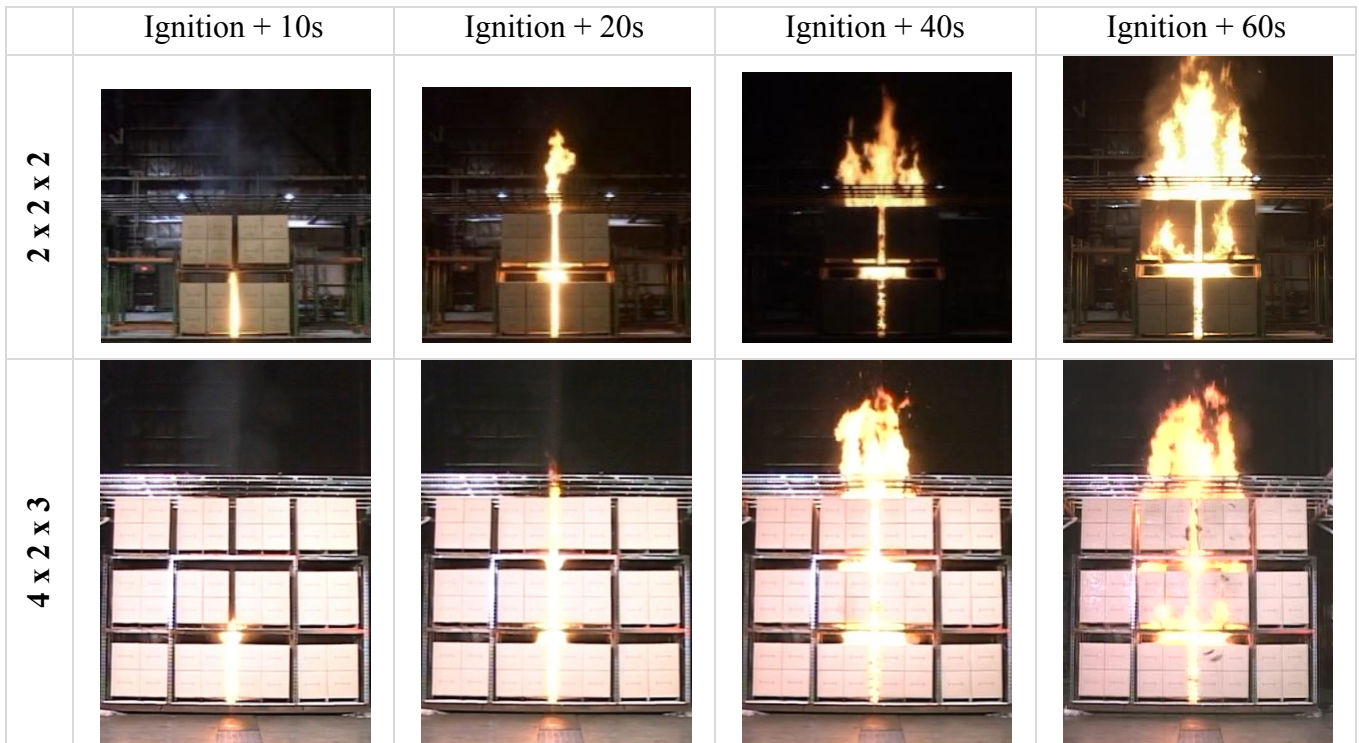
Figure 2-2: Fire development for rack storage CUP commodity at 2- and 3-tiers

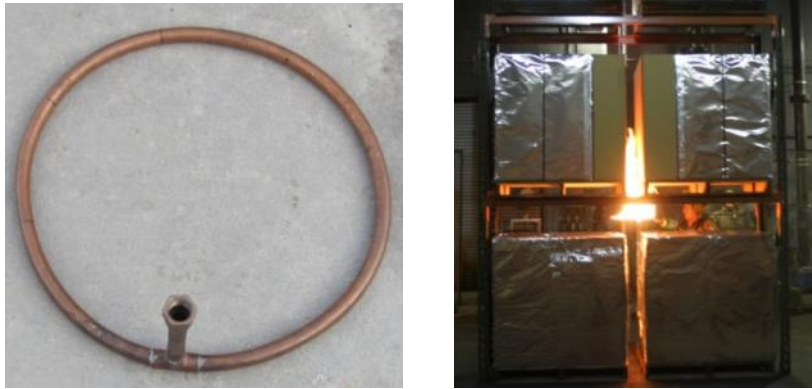
- 4) Ignition was accomplished with a 0.4 m (16 in.) diameter propane ring burner located on top of the first tier commodity, centered within the flue. Propane was supplied at a rate of 1.1 ft³/min (30 L/min).

Figure 4-16: Propane ring burner (left) within the rack and fire size within rack (right)

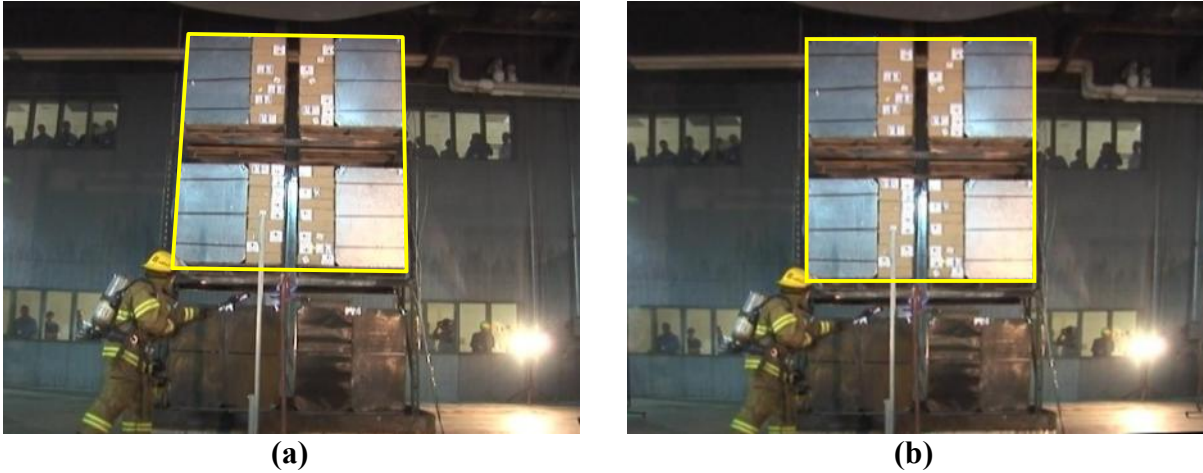
Figure 4-21: Example of perspective correction. (a) Uncorrected image and (b) image after correction

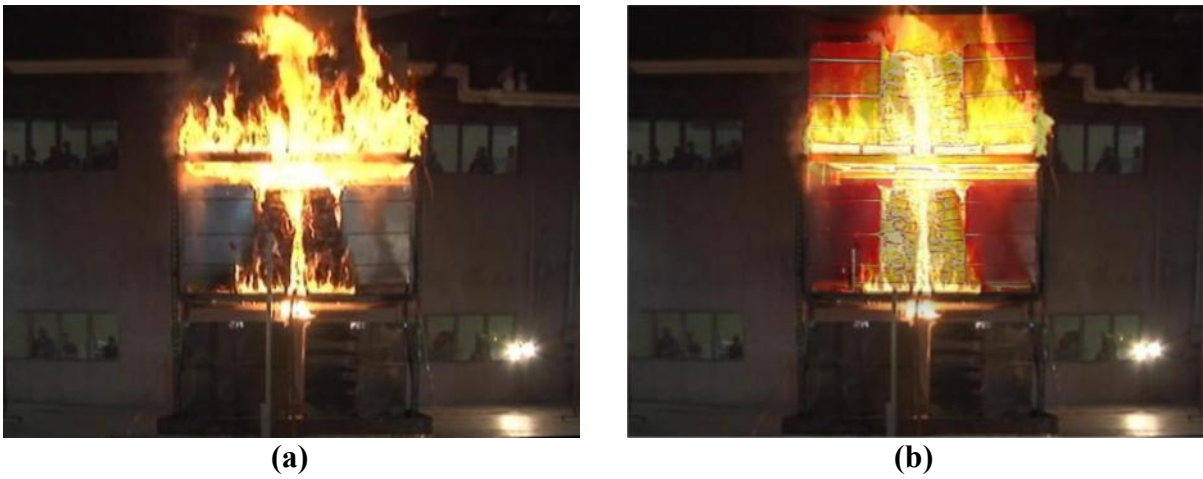
Figure 4-22: Example of IR image registration. (a) Visual image and (b) IR image registered on the top two tiers

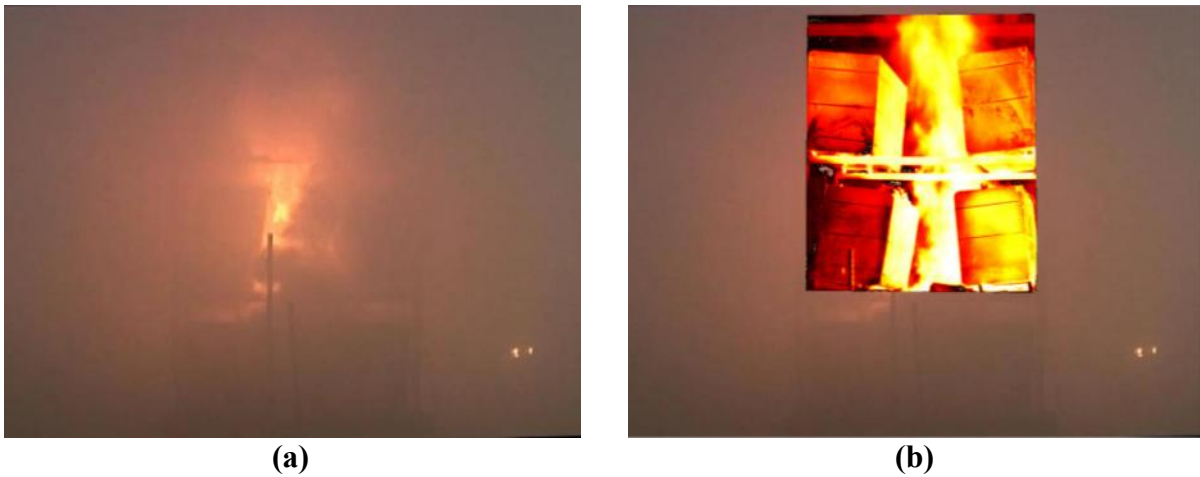
Figure 4-23: Example of the LWIR camera's ability to see through smoke and steam. (a) Visual image and (b) IR image registered on the top two tiers

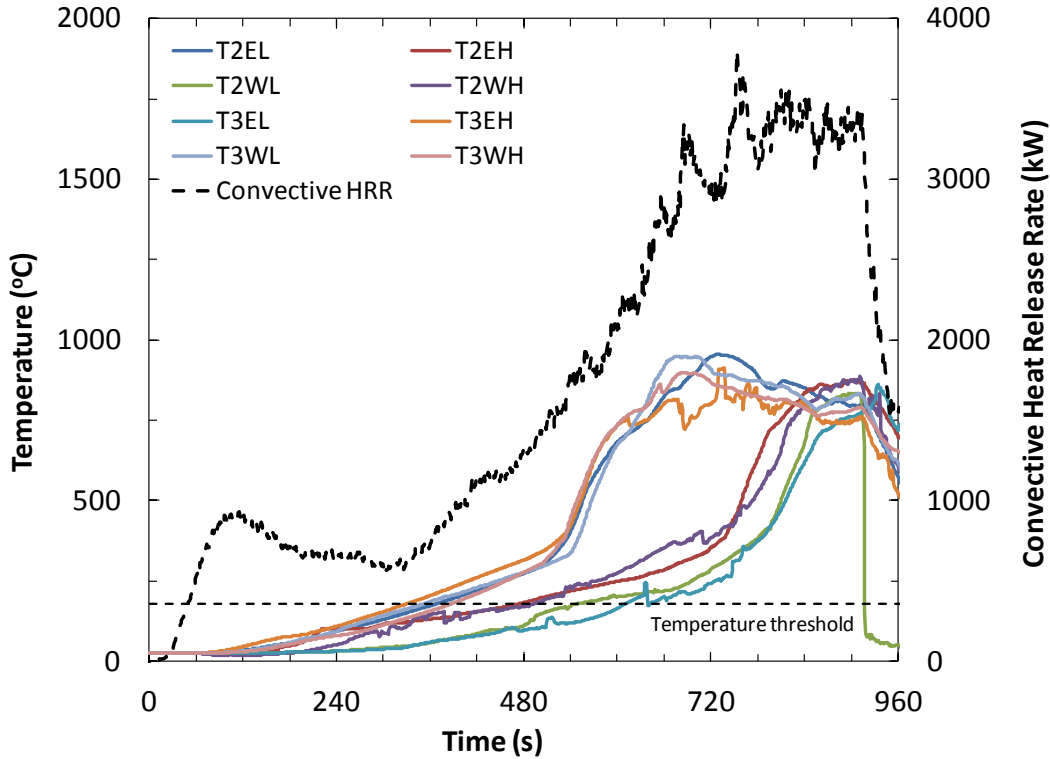
100°C/min) [29]. For this test, the threshold temperature was first exceeded by the thermocouple located on tier 3, east commodity, high elevation (T3EH) at 315 s after ignition.

Figure 4-29: Internal heating of commodity using thermocouples at the interface of the metal liner and test commodity during Li-ion polymer cell test (Test 13)

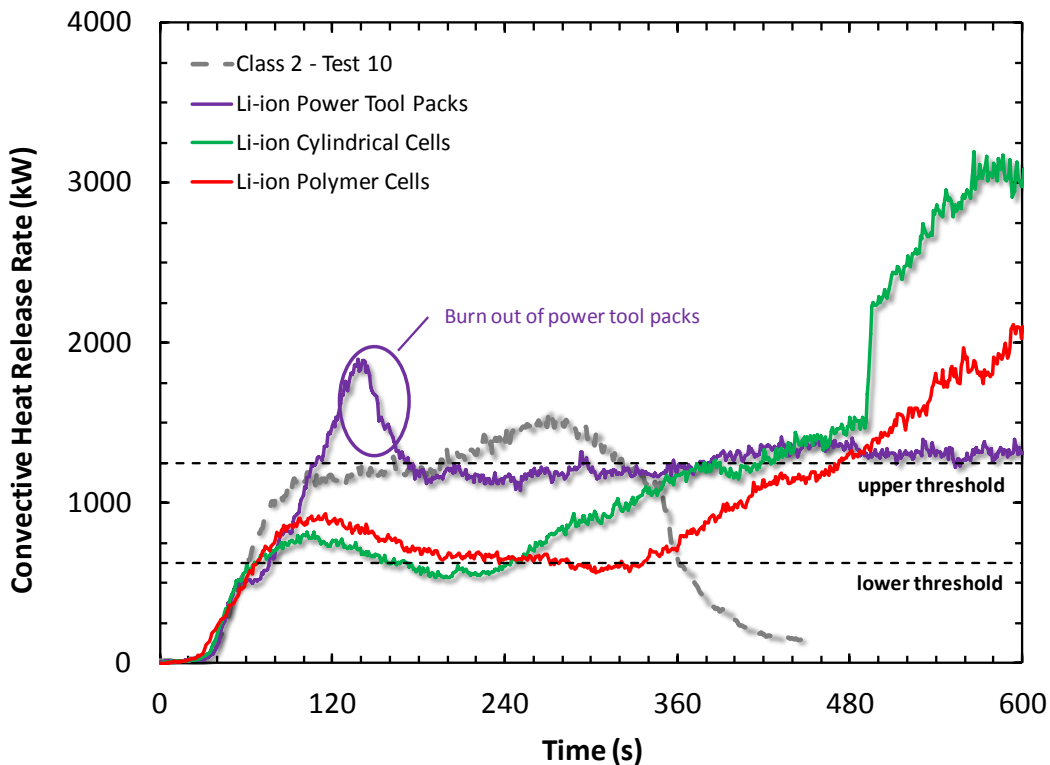
Figure 4-32: Convective HRR for Class 2 commodity and Li-ion battery commodities (subset of data presented in Section 4.8)

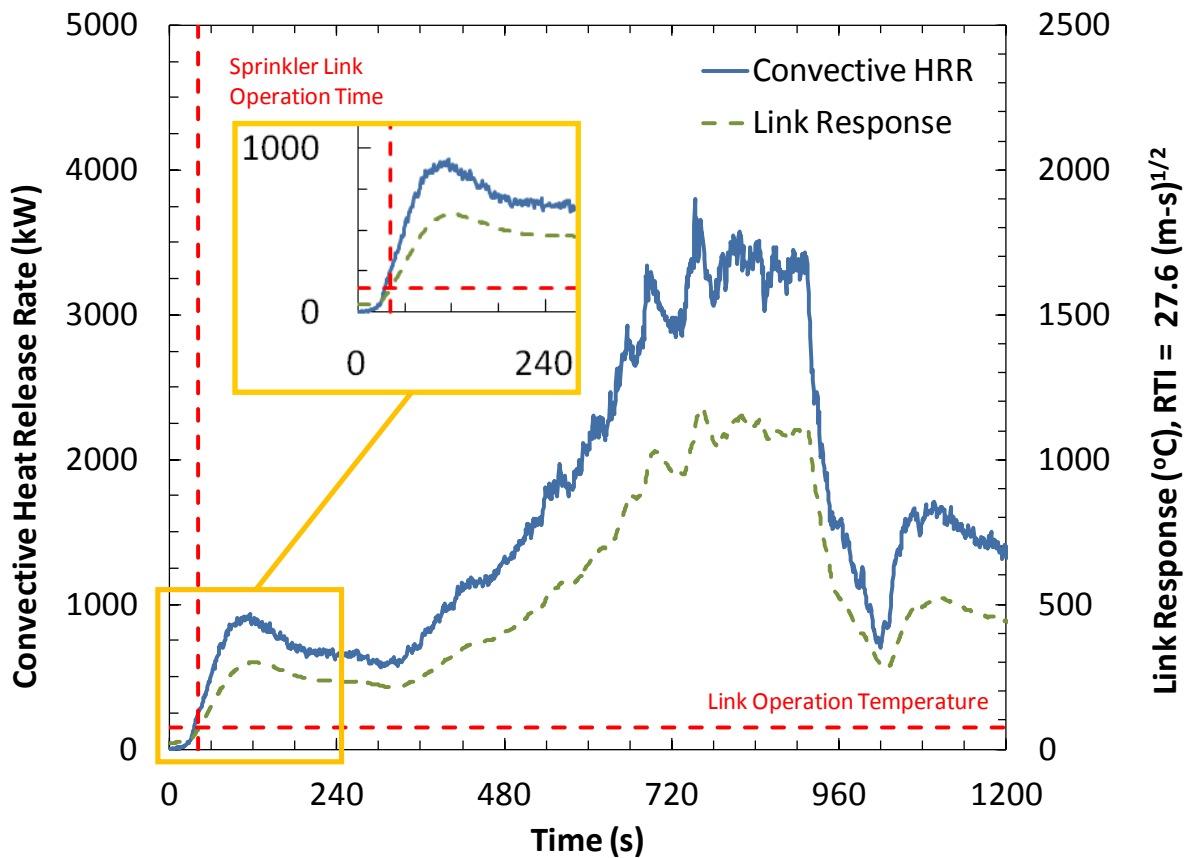
Figure 4-33: Example of sprinkler link response during Li-ion polymer cell test; quick-response sprinkler with a 74°C temperature rating below a 3.0 m ceiling

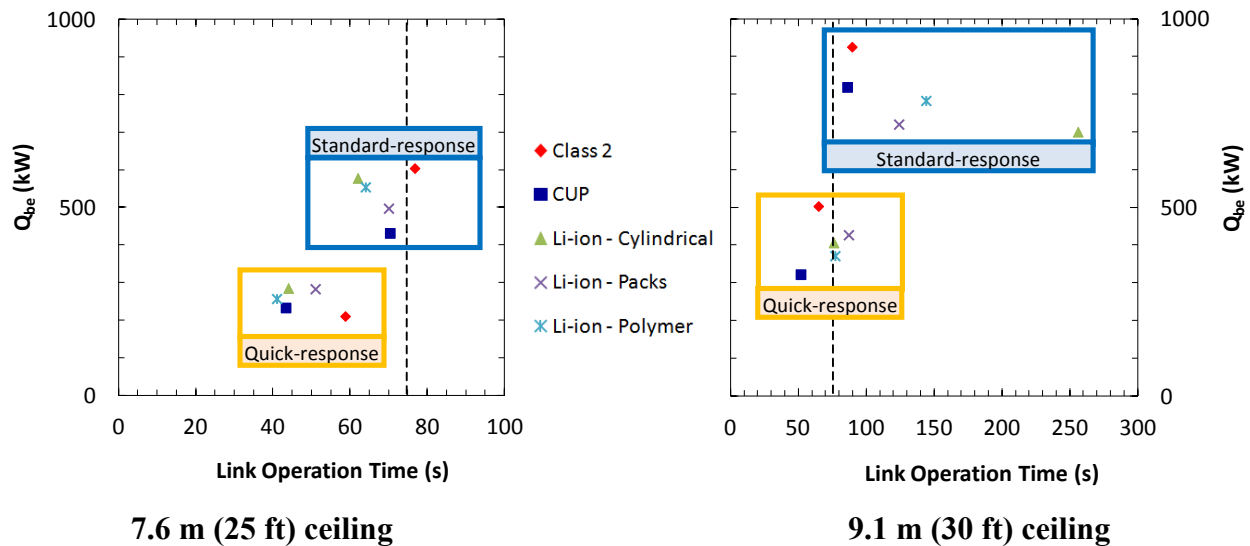
Figure 4-34: Summary of predicted link operation times versus fire size, Q_{be} , for all test conditions; vertical dashed line indicates the upper limit for the period of flammability characterization (*i.e.*, 75 ± 5 s)

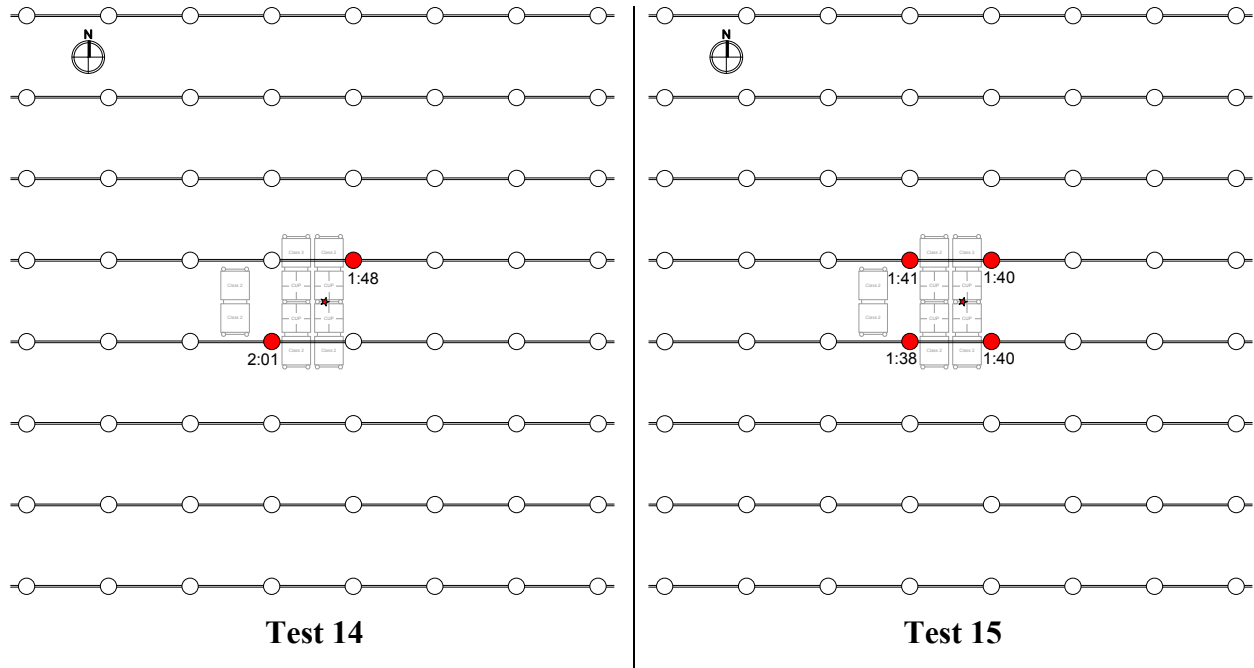
A plan view of the sprinkler operation pattern for each test is presented in Figure 5-10.

Figure 5-10: Sprinkler operation pattern for Tests 14 and 15

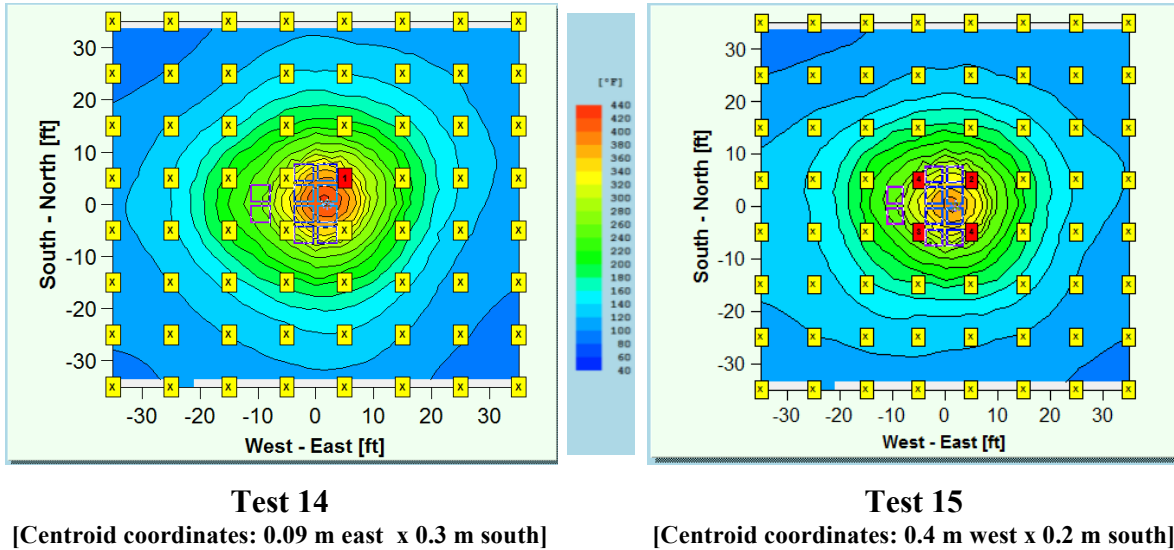
Figure 5-12: Contour plots of ceiling TC measurements at first sprinkler operation for Tests 14 and 15

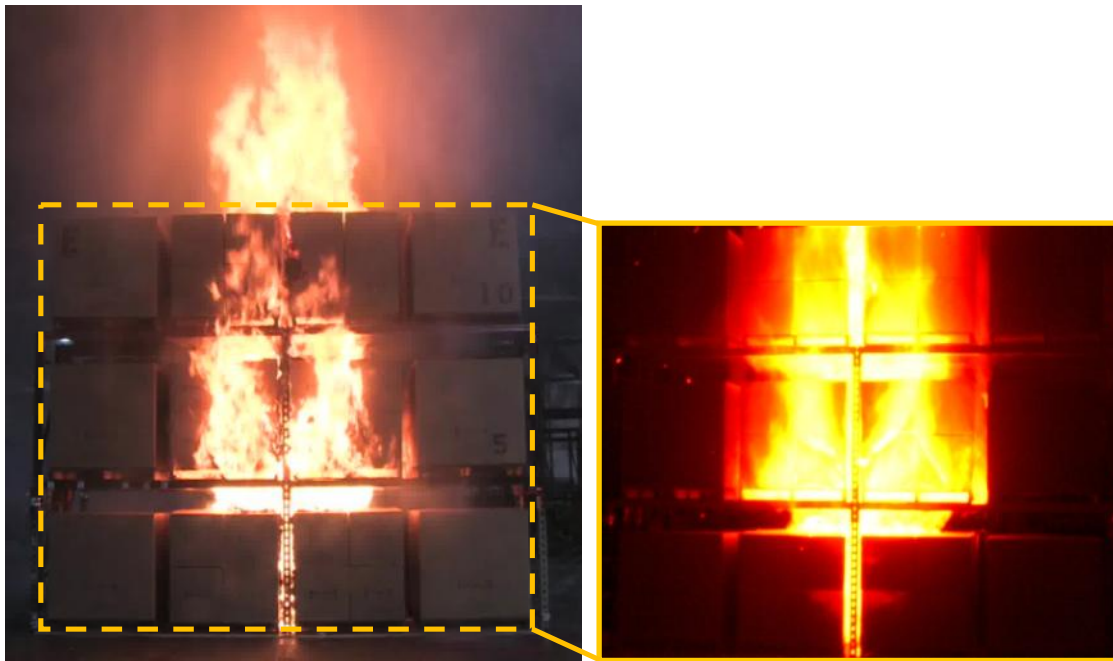
Figure 5-14: Image from HD camera (left) and IR camera (right) at first sprinkler operation [1 min 38 s] for Test 15

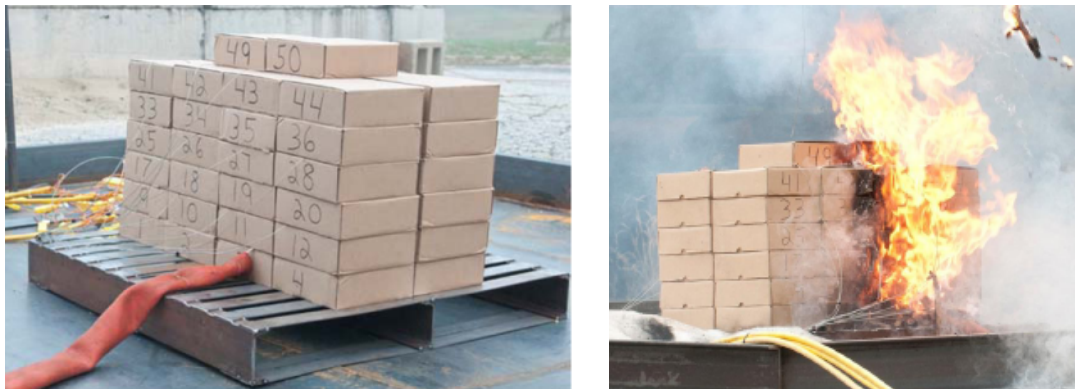
In 2012, similar cell-to-cell fire propagation was also seen for a larger test consisting of 5,000 cylindrical cells [8]. Cells were packaged in fifty 100-cell cartons and a cartridge heater was located at the bottom of the stack, Figure 6-1. Similar to the smaller tests, cell-to-cell propagation occurred slowly, gradually speeding up as the fire size increased. Significant cell rupture was observed with projectiles traveling up to 40 m (130 ft). The duration of the fire from initial smoke observation to reaction of all cells was 1 hr 5 min.

Figure 6-1: Image of 5,000 Li-ion battery test conducted by the FAA; test layout (left) and fire involving carton packaging (right) [images taken from reference 8]

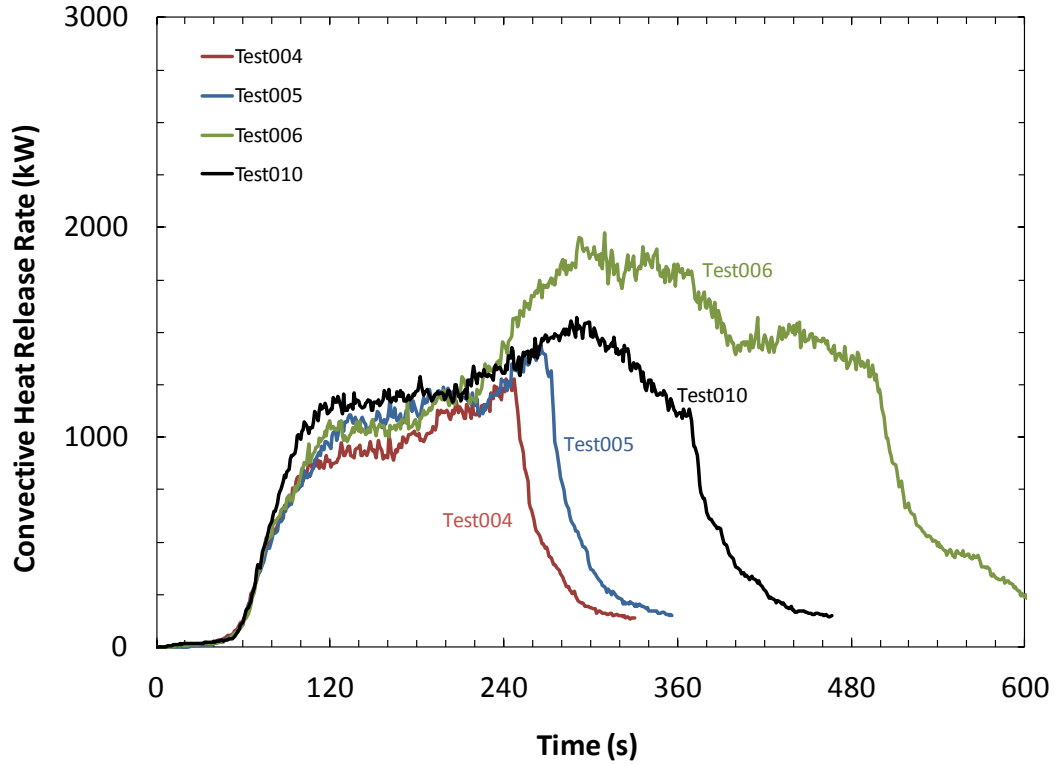
Time-resolved heat release rate data based on convective flow measurements for Tests 4 through 6 and 10 are shown in Figure A-5. Comparable heat release rate data based on oxygen consumption and carbon monoxide/dioxide are shown in Figure A-6 and Figure A-7, respectively. In each figure, the test time has been slightly offset to align the initial fire growth periods. Additionally, the notable increase in the heat release rate starting at 200 s for Test 6 occurred as the aluminum foil covering part of the carton fell away, allowing unwanted fire propagation along the previously unexposed combustible material. Due to an instrumentation failure, no heat release based on carbon monoxide/dioxide generation was reported for Tests 4 through 6 in Figure A-7.

Figure A-5: Convective heat release rates for Tests 4 - 6, 10

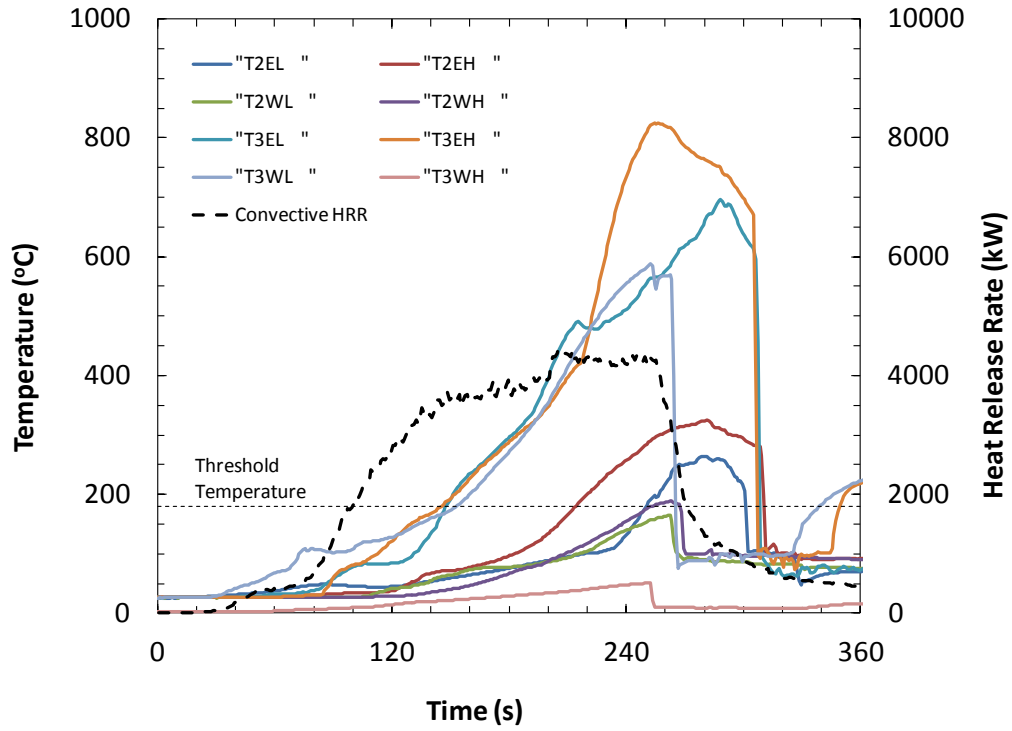
Figure A-14 shows the measurements from the TCs located at the interface between the test commodity and the metal liner as detailed in Section 4.4 for Test 7. TCs were mechanically fastened to the metal liner along the horizontal centerline of each commodity at elevations of 0.36 m (14 in.) and 0.72 m (28 in.) above the wood pallet. These TCs are referenced by their location with the array based on tier (T2 for tier 2 or T3 for tier 3), pallet location within the array (east or west) and elevation (low = 0.36 m above pallet or high = 0.72 m above pallet). The convective heat release rate is included for reference to the time evolution of the fire. The threshold temperature of 180°C (356°F) was added based on the oxidation temperature of electrolyte that results in a high-rate runaway reaction (peak rates > 100°C/min). For this test, the threshold temperature was first exceeded by the TC located on tier 3, east commodity, high elevation (T3EH) at 145 s after ignition. Note that the sudden reduction in measured temperature occurring after 240 s reflects the application of suppression water to terminate the test. Similar results are shown in Figure A-15 (T3EH exceeded threshold temperature at 171 s) and Figure A-16 (T3WH exceeded threshold temperature at 158 s) for Tests 8 and 9, respectively.

Figure A-14: Liner thermocouples - Test 7

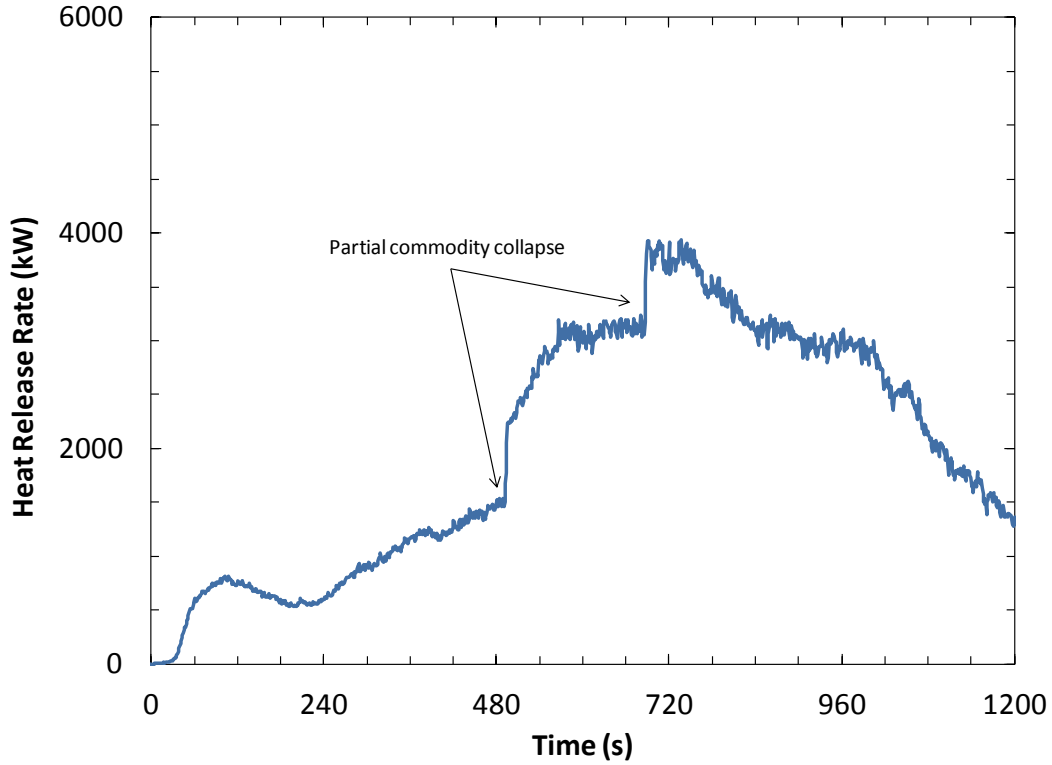
**Figure A-19: Convective heat release rate - Test 11
(Chemical HRRs not included for Li-ion battery tests)**

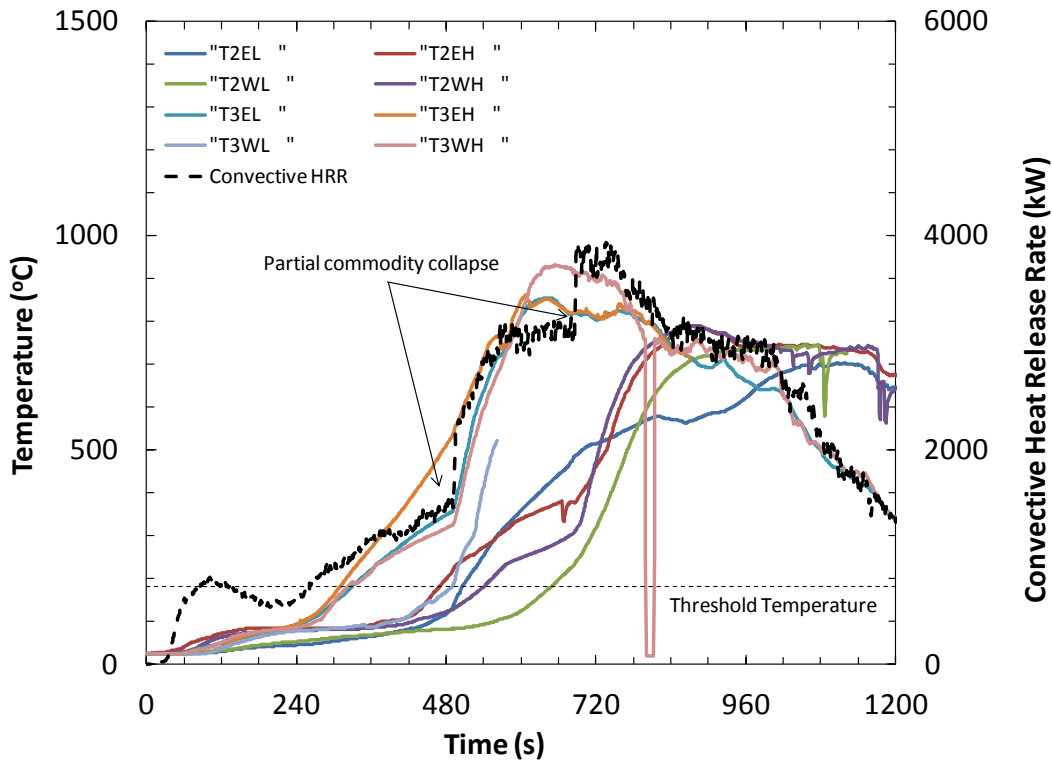
Figure A-20 shows the measurements from the TCs located at the interface between the test commodity and the metal liner as detailed in Section 4.4. TCs were mechanically fastened to the metal liner along the horizontal centerline of each commodity at elevations of 0.36 m (14 in.) and 0.72 m (28 in.) above the wood pallet. These TCs are referenced by their location with the array based on tier (T2 for tier 2 or T3 for tier 3), pallet location within the array (east or west) and elevation (low = 0.36 m above pallet or high = 0.72 m above pallet). The convective heat release rate is included for reference to the time evolution of the fire. The threshold temperature of 180°C (356°F) was added based on the oxidation temperature of electrolyte that results in a high-rate runaway reaction (peak rates > 100°C/min). For this test, the threshold temperature was first exceeded by the TC located on tier 3, east commodity, high elevation (T3EH) at 309 s after ignition. Note that several of the data series are truncated (T3EH, T3WL, T2WL) due to damage to the TCs, which occurred after the temperature threshold was substantially exceeded.

Figure A-20: Liner thermocouples - Test 11

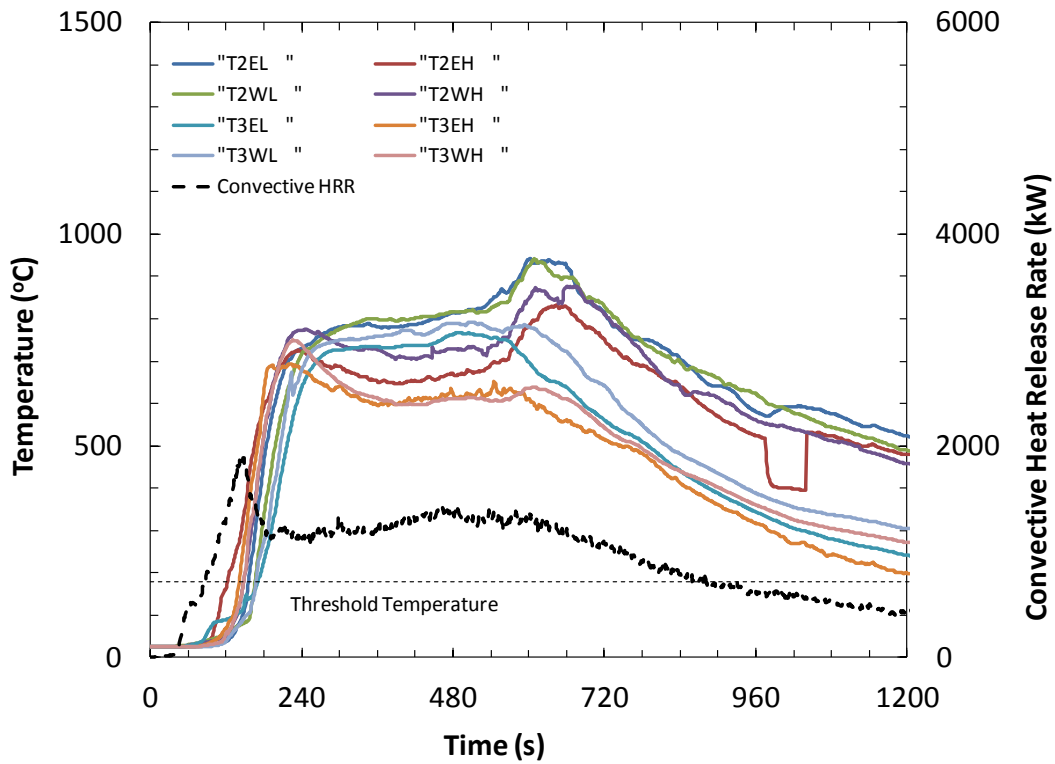
Figure A-24: Liner thermocouples - Test 12

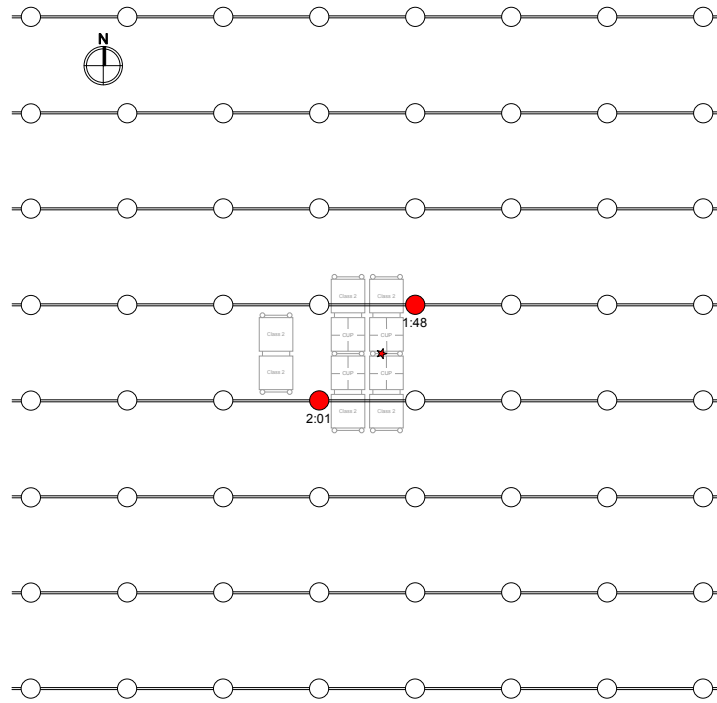
Figure C-3: Plan view of sprinkler operation pattern - Test 14

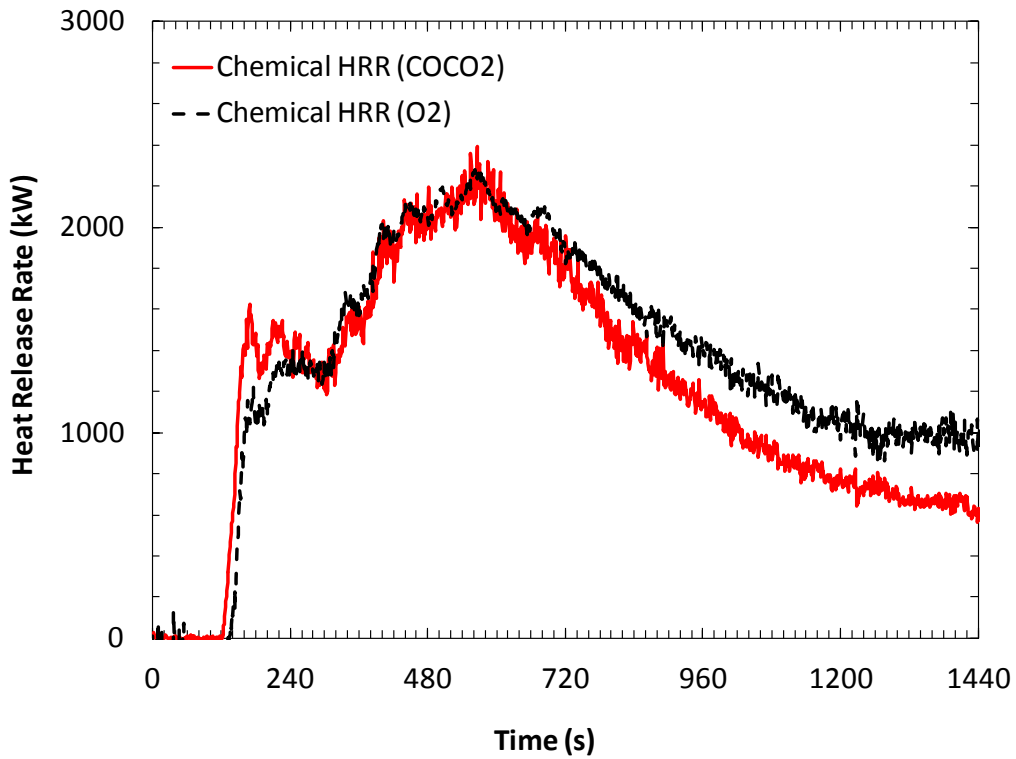
Figure C-9: Chemical heat release rates - Test 14

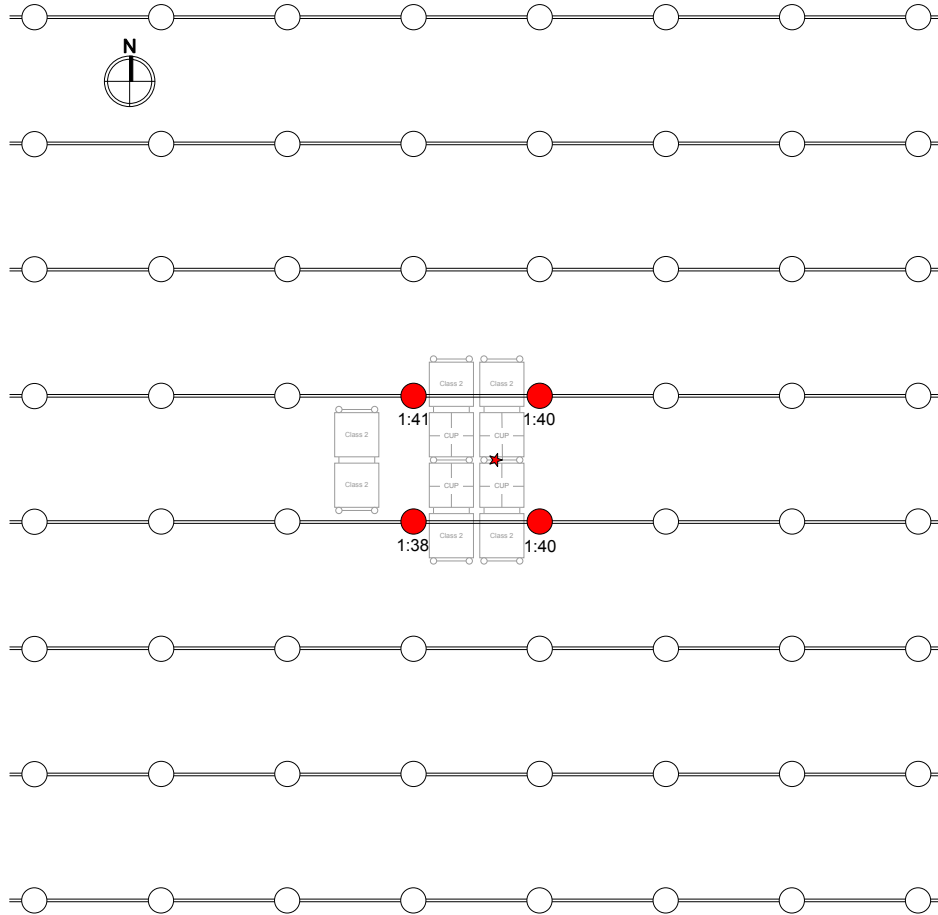
Figure C-12: Plan view of sprinkler operation pattern - Test 15

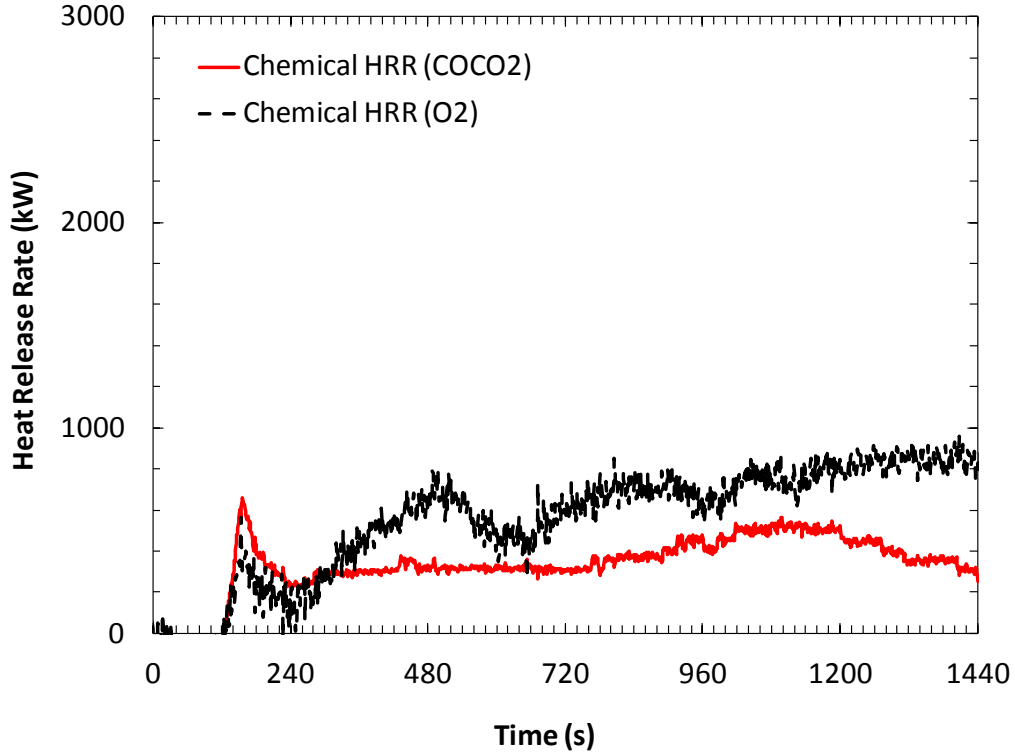
Figure C-18: Chemical heat release rates - Test 15
